June 28, 2019
File No. 262018.063

Subject: Department of Natural Resources Washington Geological Survey,
School Seismic Safety Assessment Project, Contract No. AE 410 -
Seismic Evaluation for **Methow Valley School District**

School Buildings Evaluated in the Methow Valley School District

1. Liberty Bell Junior Senior High School, Main Building
2. Methow Valley Elementary School, Main Building

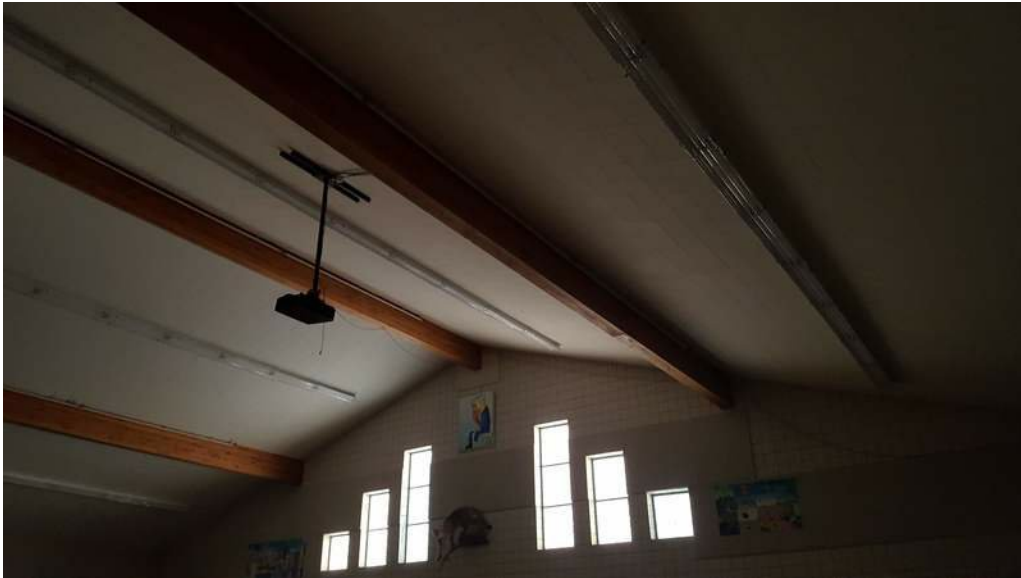
Figure 1-1. Vaulted ceiling in the cafeteria.

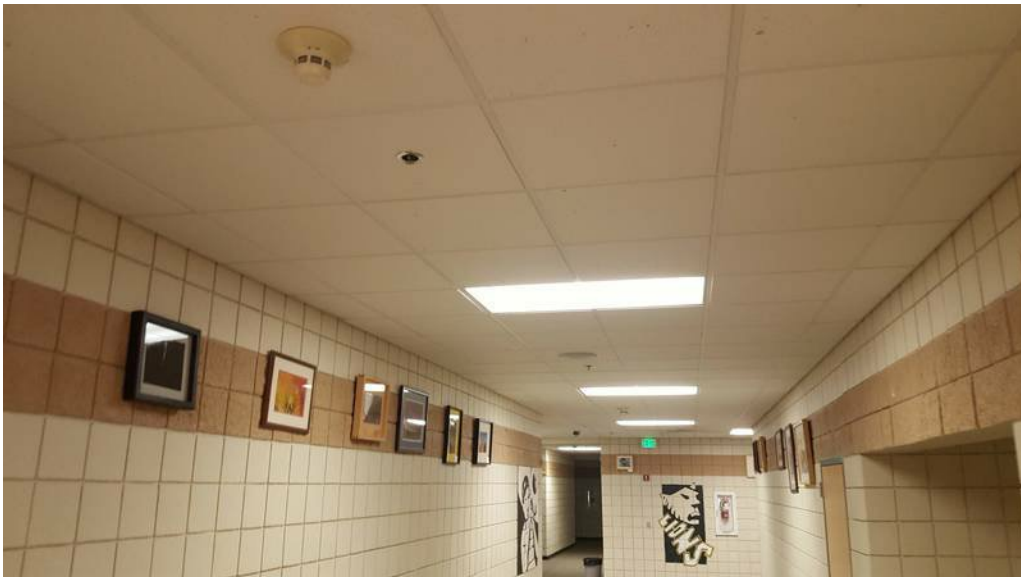
Figure 1-2. Corridor with drop-in acoustical ceiling, lighting, and fire suppression systems.

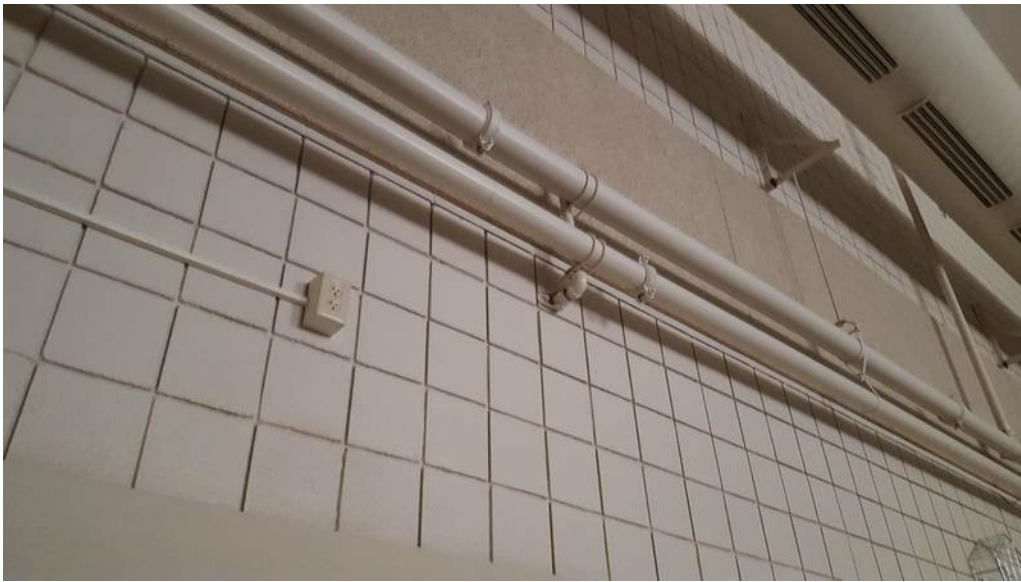
Figure 1-3. Piping mounted to the CMU wall.

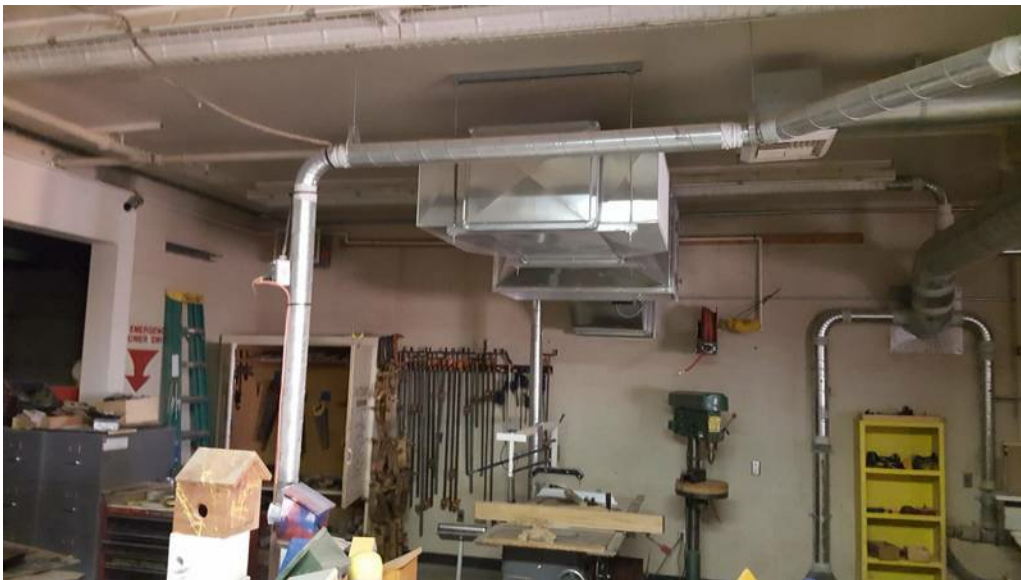
Figure 1-4. Mechanical unit mounted to the ceiling in the wood shop.

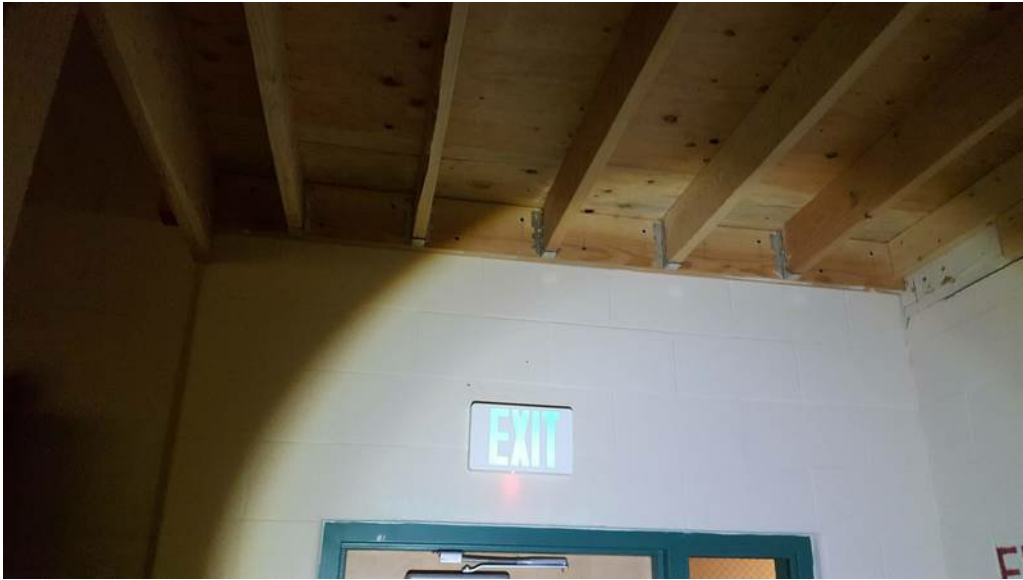
Figure 1-5. Second floor framing visible from below.

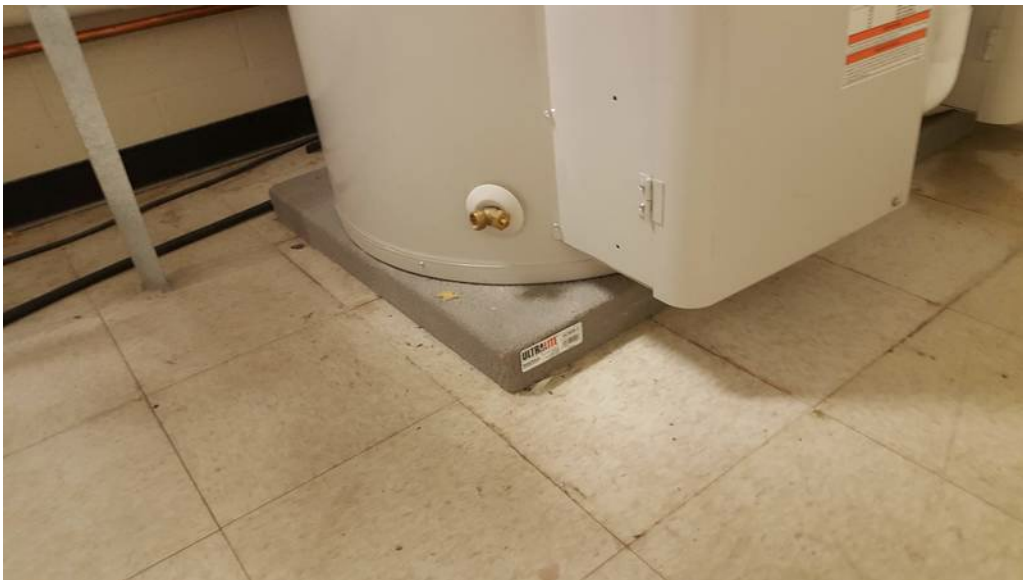
Figure 1-6. Water heater base. No seismic strapping was observed on water heaters.

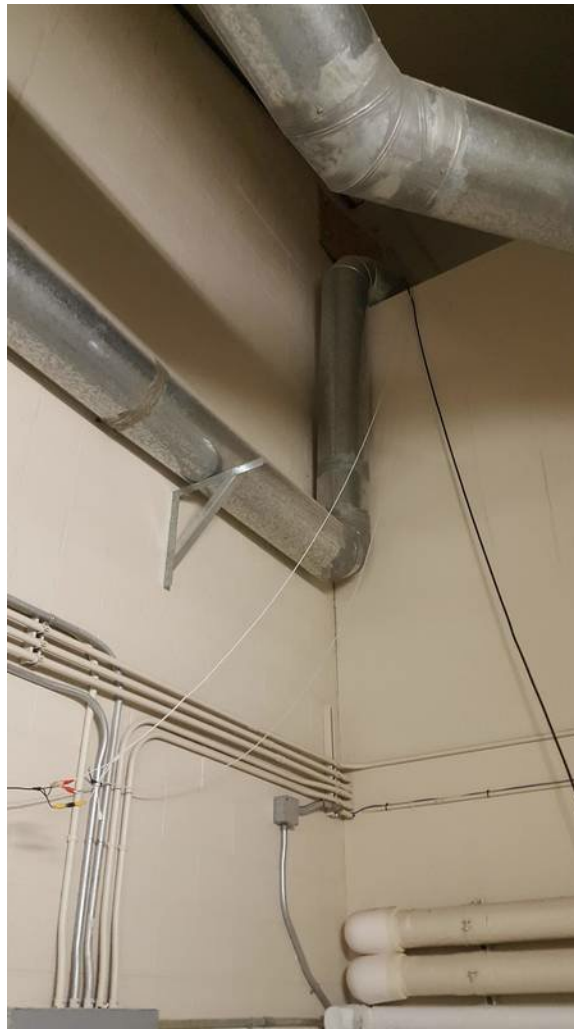
Figure 1-7. Duct work routing.

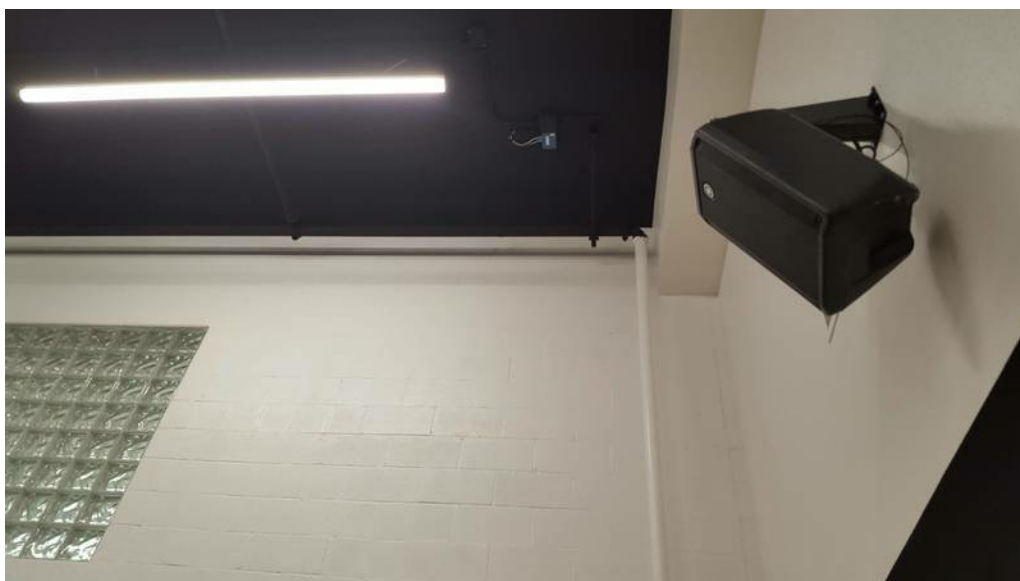
Figure 1-8. CMU wall with glass block. Speaker mounted to an infill wall.

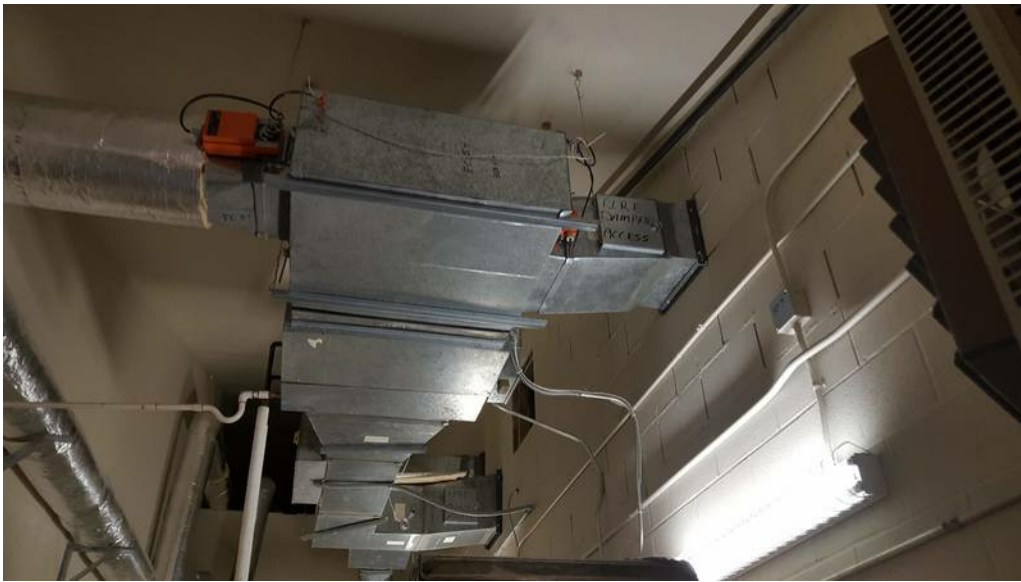
Figure 1-9. Overhead mechanical unit/duct work in mechanical space.

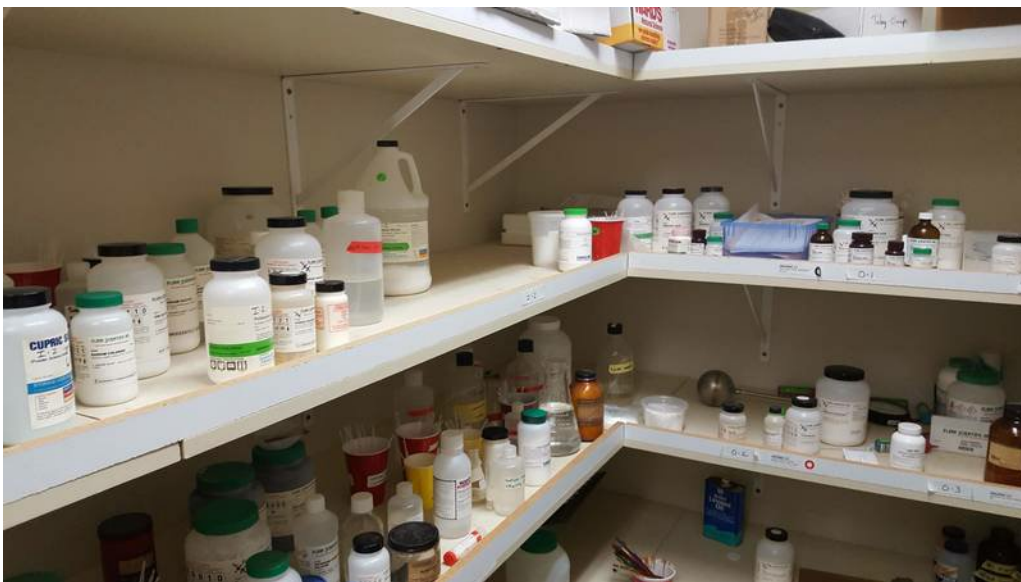
Figure 1-10. Chemical storage in science room.

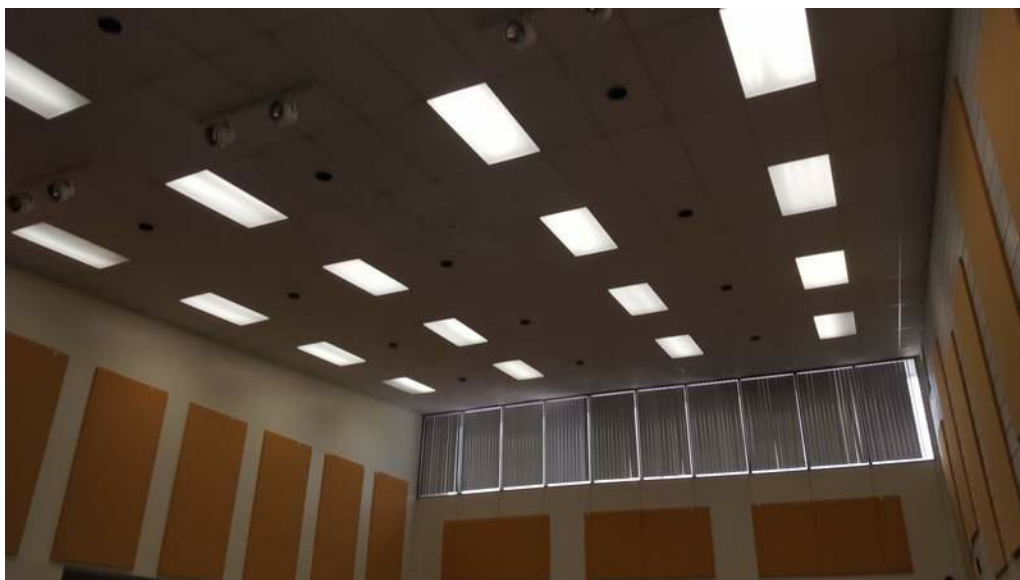
Figure 1-1. Ceiling in gymnasium.

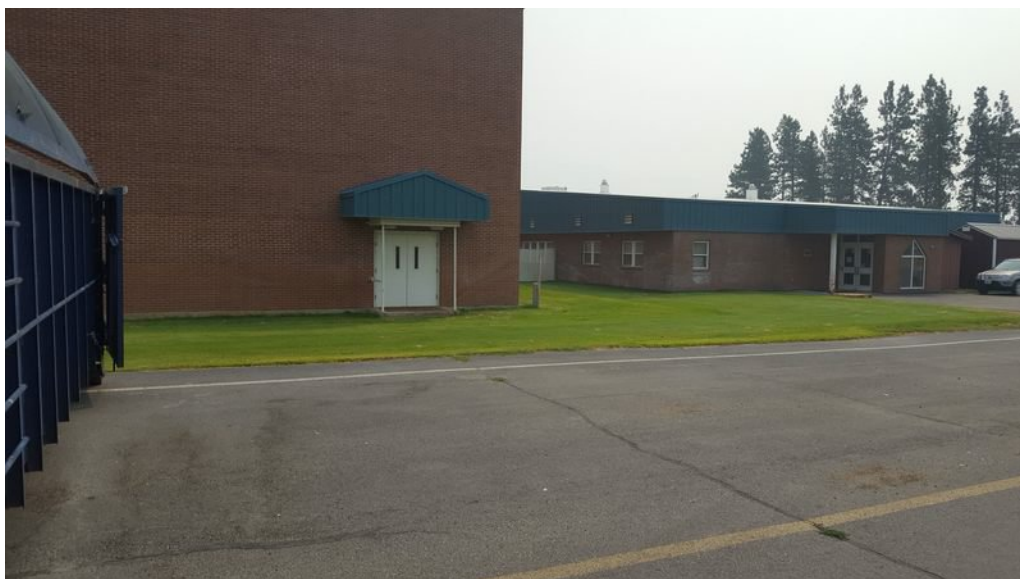
Figure 1-2. Exterior view at gym.

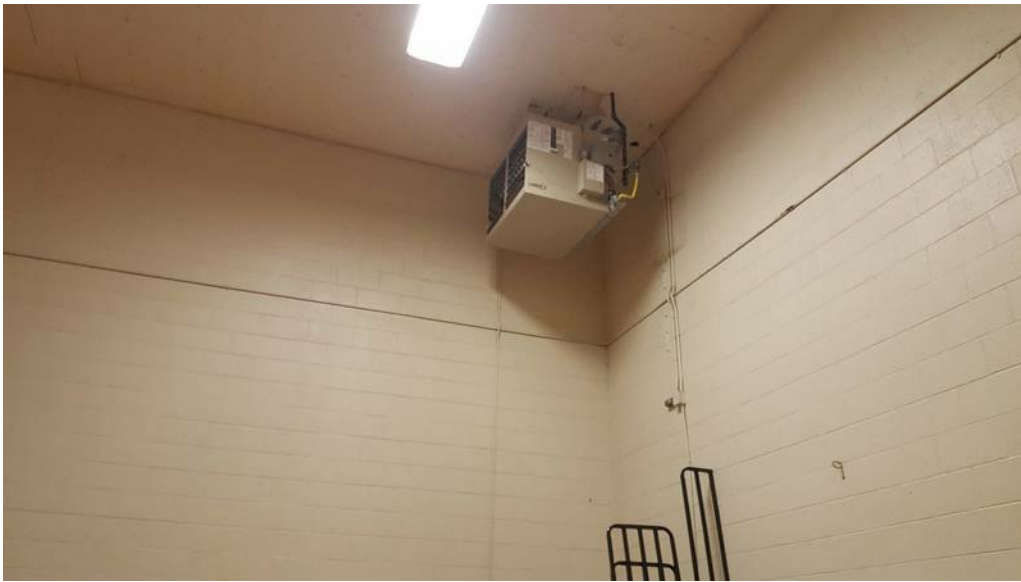
Figure 1-3. Overhead mechanical unit in gym.

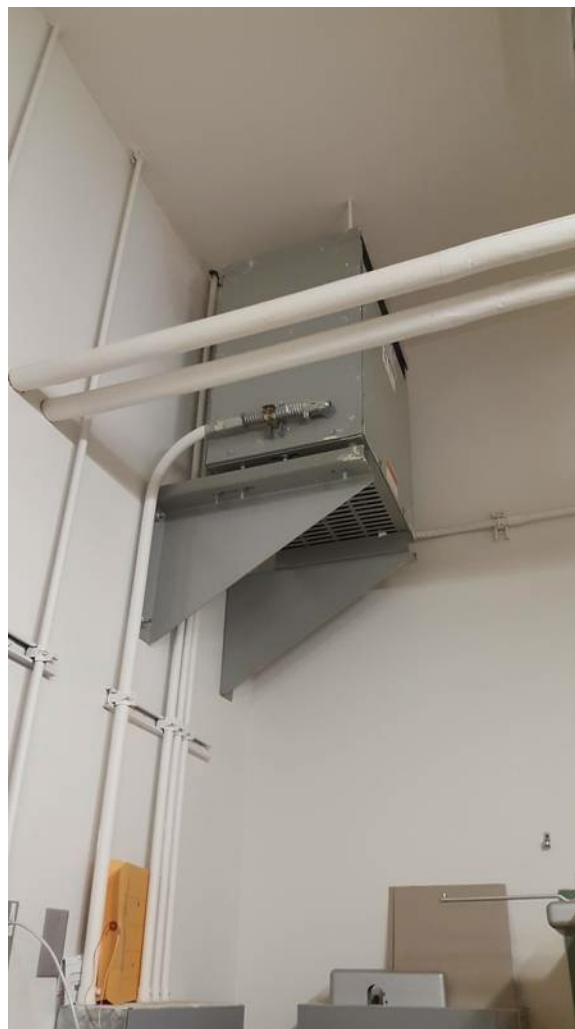
Figure 1-4. Overhead mechanical unit.

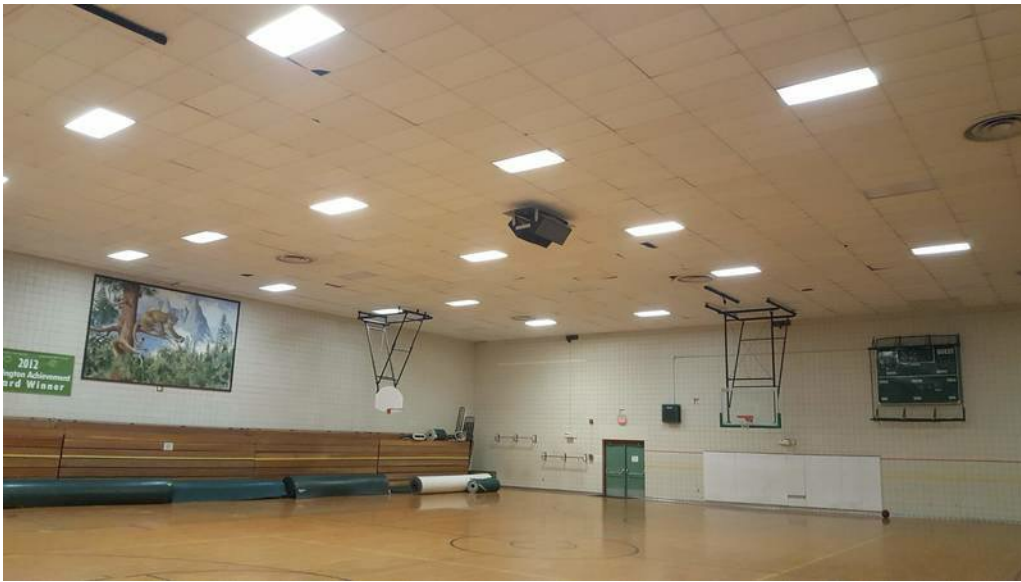
Figure 1-5. Overview of gymnasium.

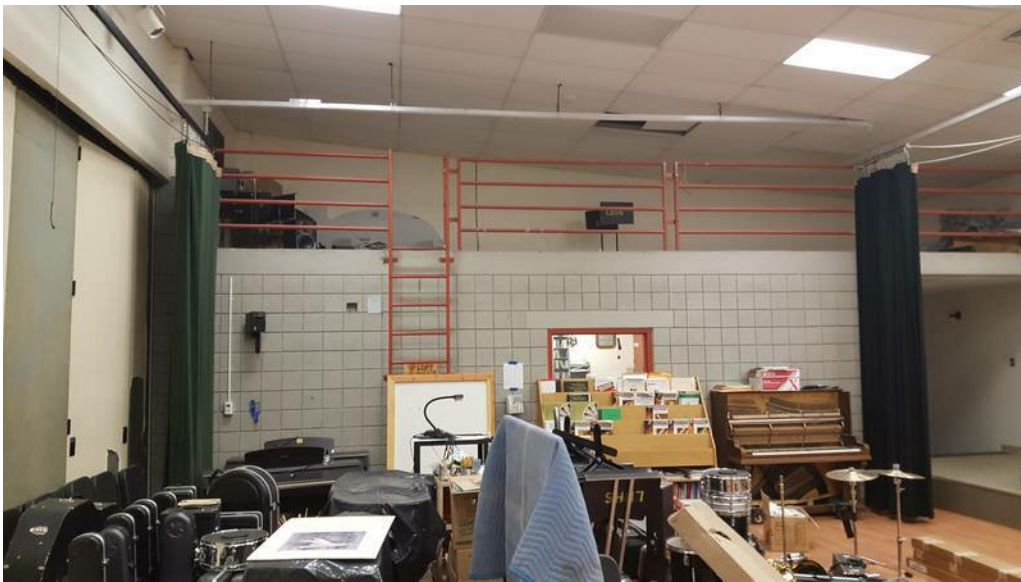
Figure 1-6. Storage mezzanine in music classroom.

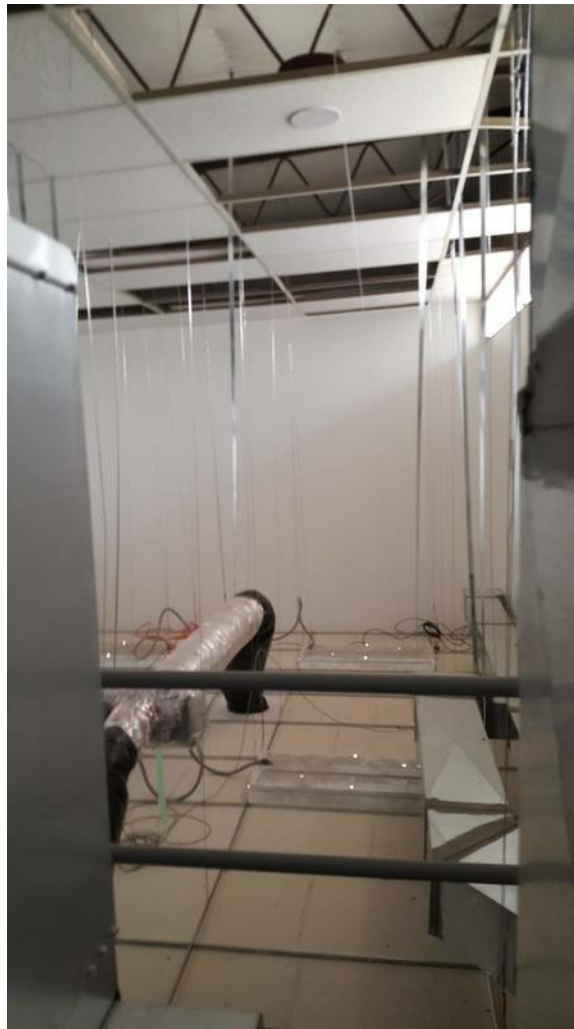
Figure 1-7. Mechanical space between roof and ceiling in addition.

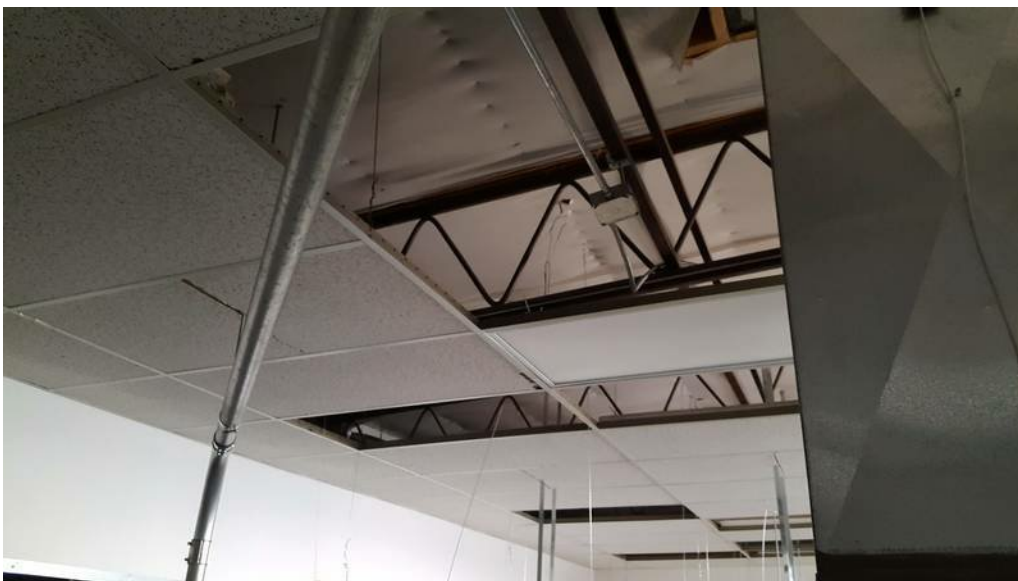
Figure 1-8. View of open web steel joists and metal deck roof structure in addition.

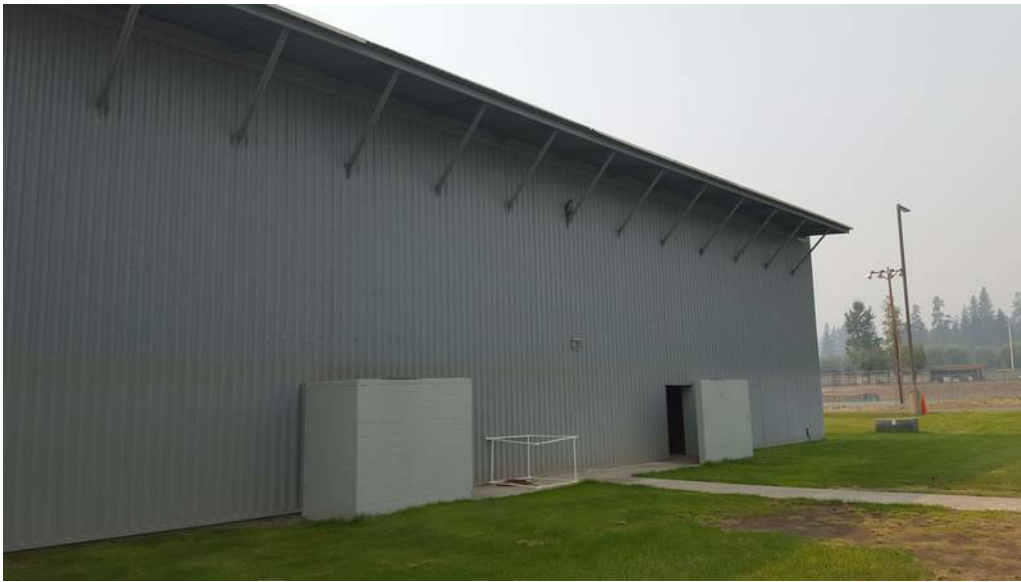
Figure 1-9. North exterior wall at addition.

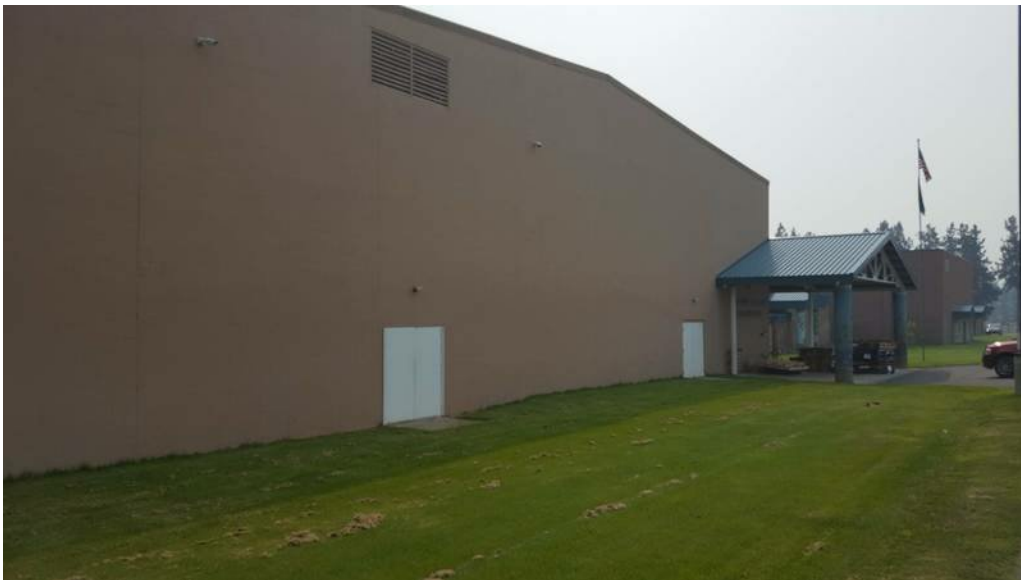
Figure 1-10. West exterior wall at addition.
